Naval Research Laboratory

NRL/MR/6180-92-7145

## Findings of Portable Air Mover Tests on the ex-USS SHADWELL

September 30, 1992

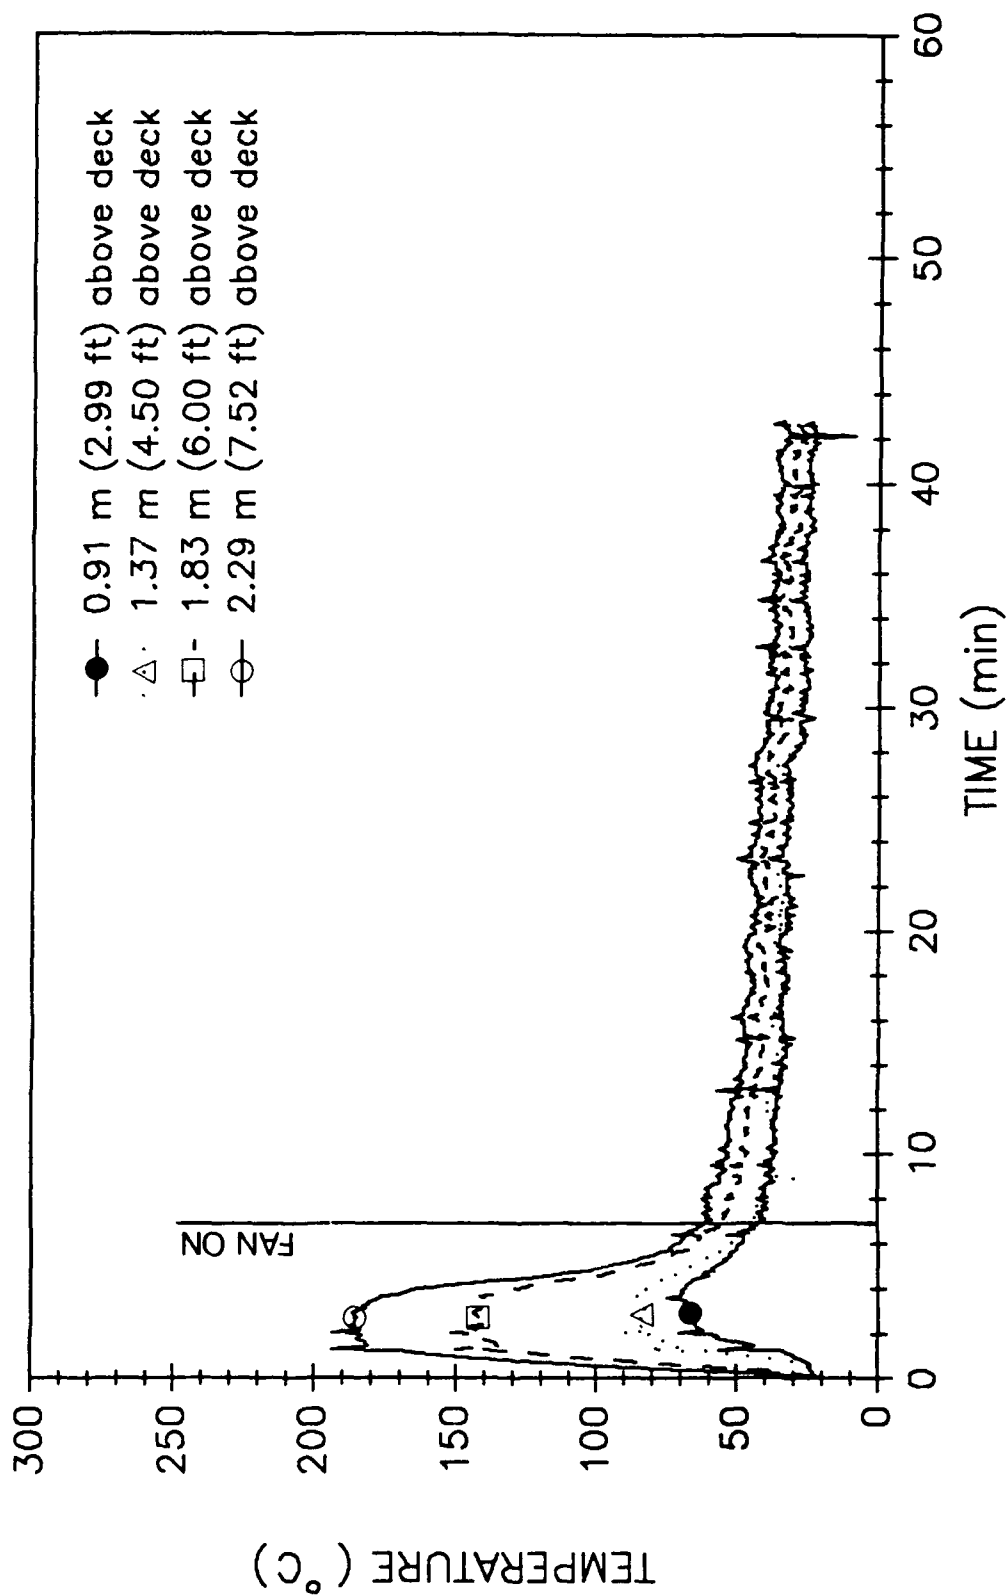
Fig. 66 - Temperature in BERTHING 1 (3-79-2) during FAN\_18  
using RAMFAN 965 kPa (140 psi)

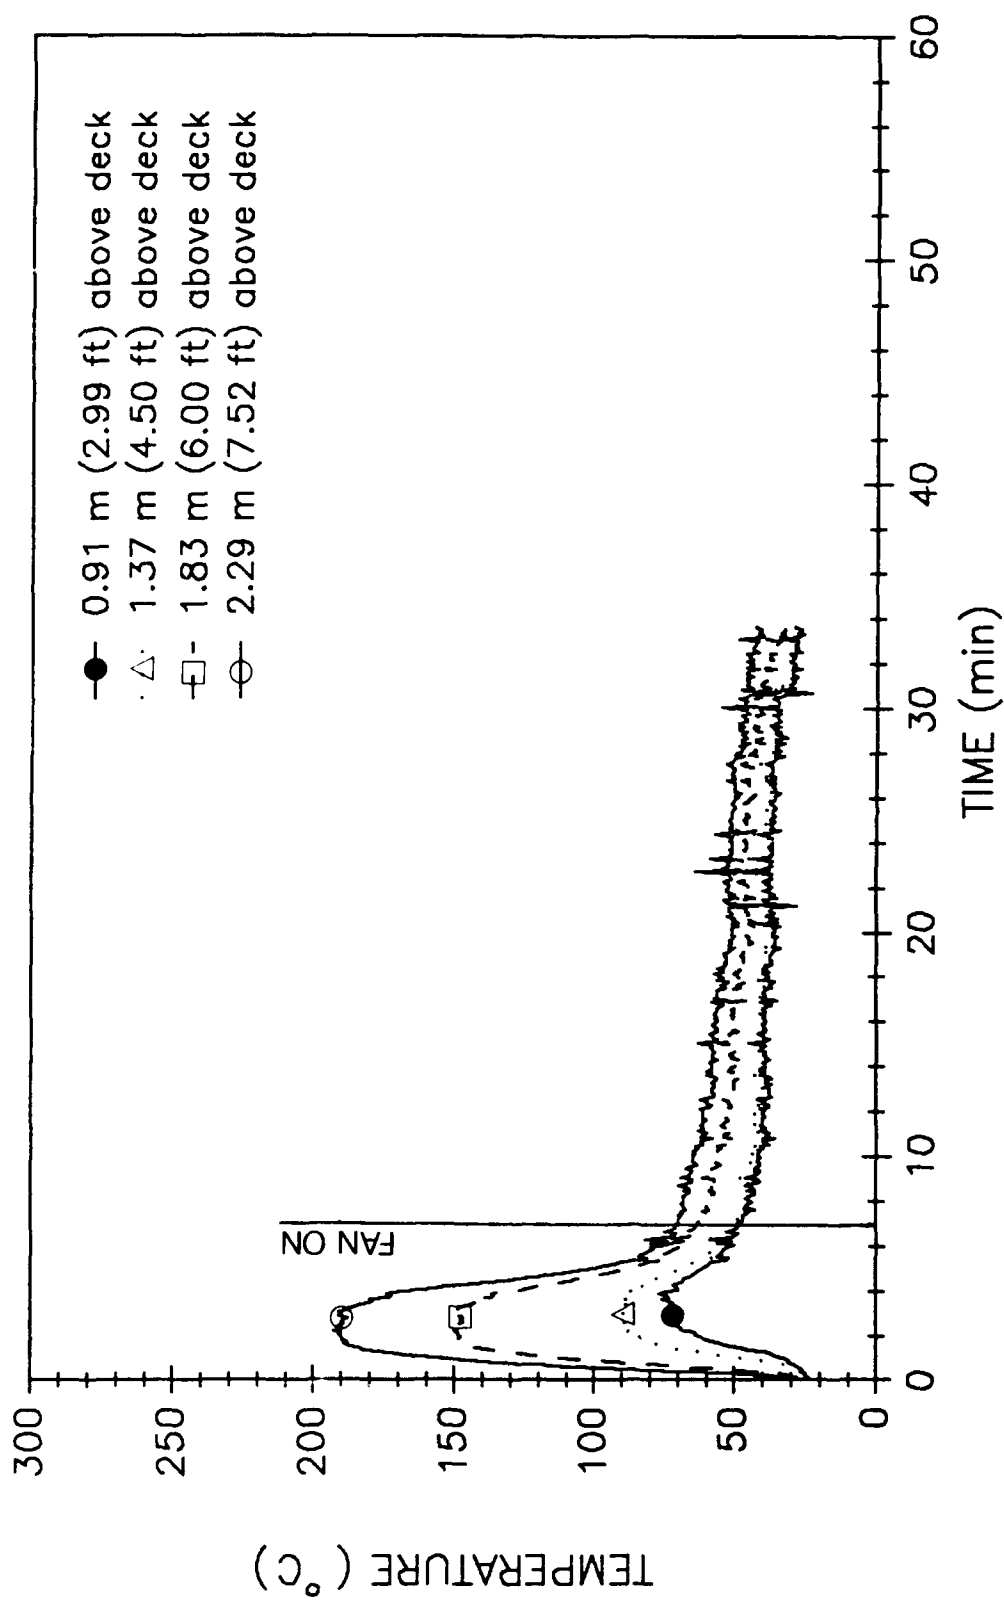
Fig. 67 - Temperature in BERTHING 1 (3-79-2) during FAN\_19  
using Red Devil 25.4 cm (10 in) duct

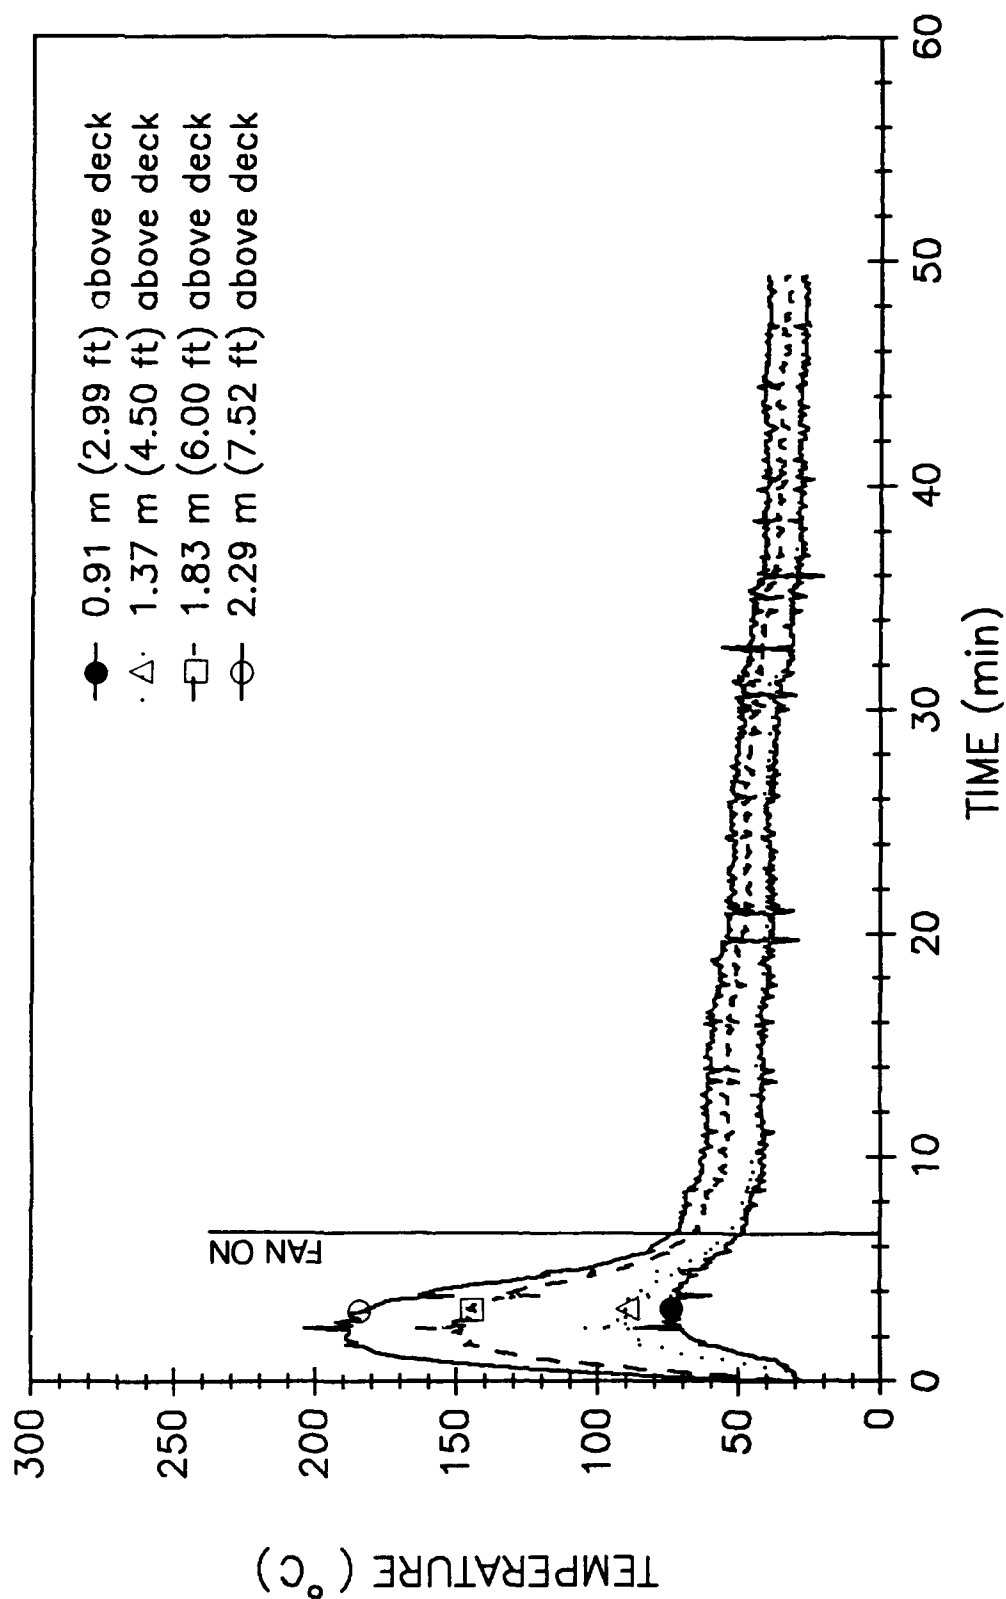
Fig. 68 - Temperature in BERTHING 1 (3-79-2) during FAN\_20  
using RAMFAN 345 kPa (50 psi)

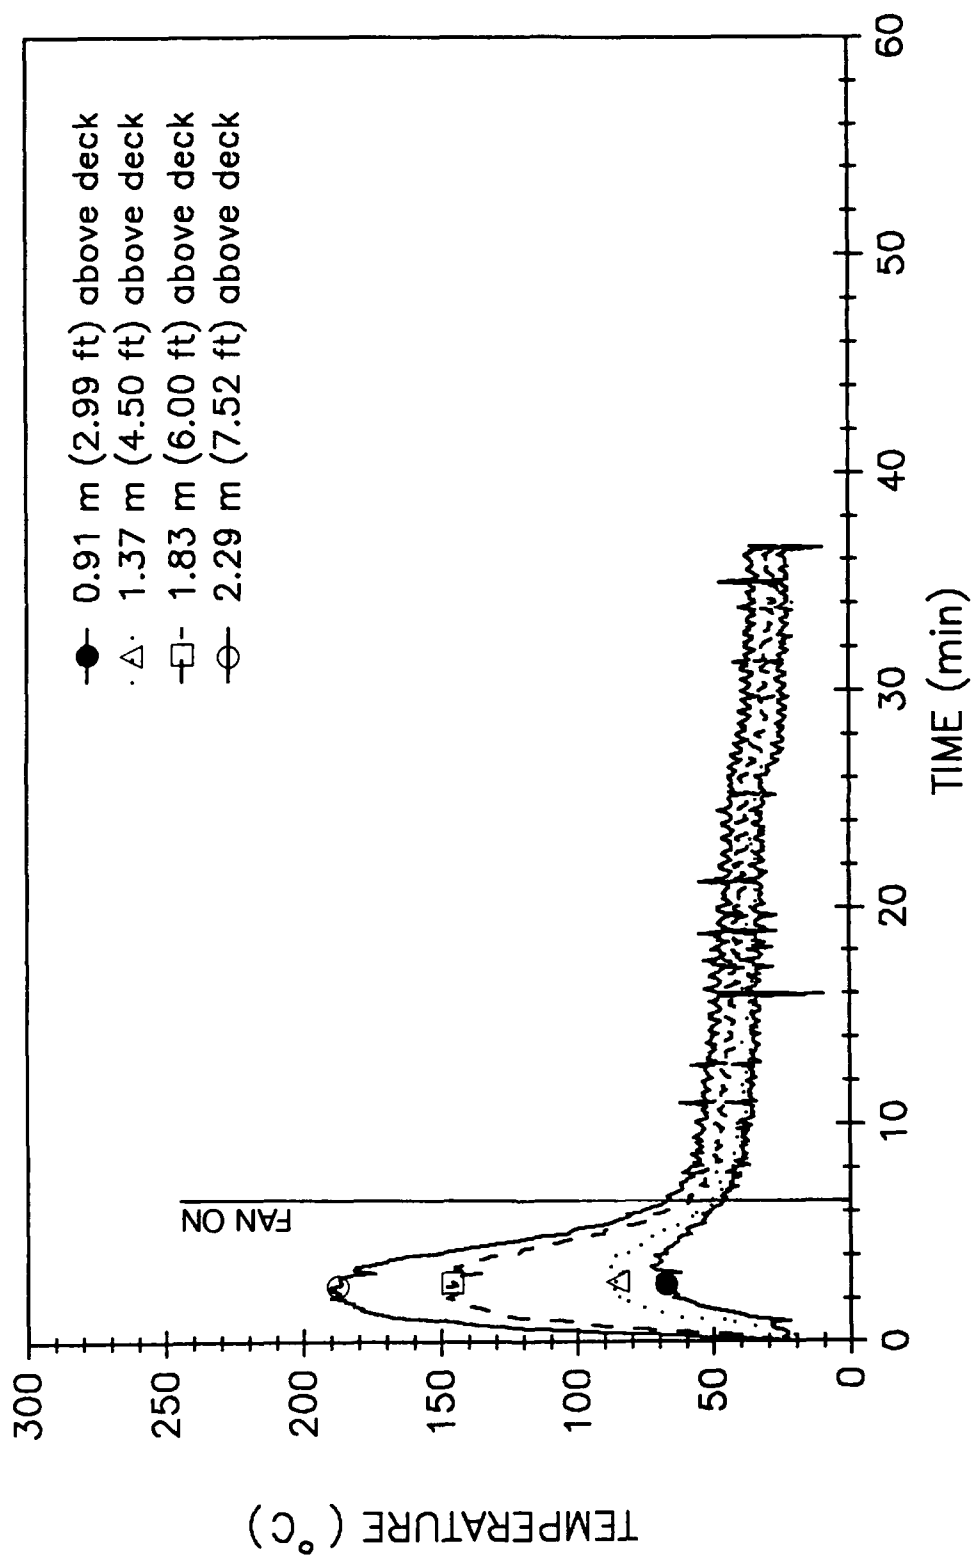
Fig. 69 - Temperature in BERTHING 1 (3-79-2) during FAN\_22 using RAMFAN 1000 kPa (145 psi)

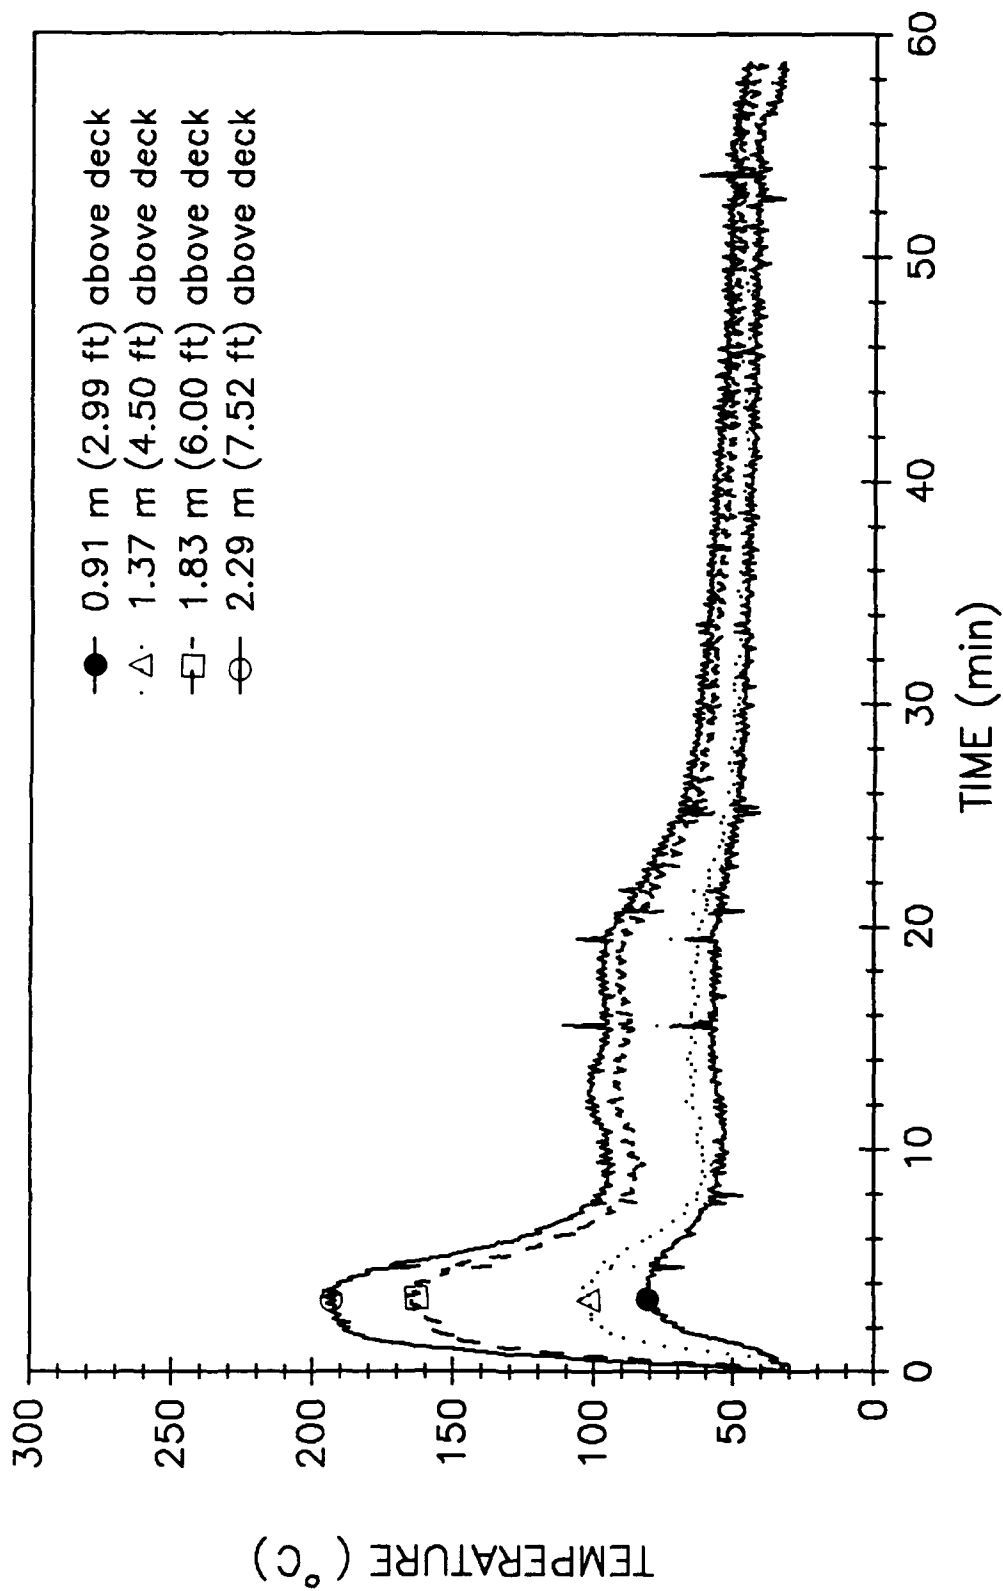
Fig. 70 - Temperature in BERTHING 1 (3-79-2) during FAN\_39 using natural venting

A natural venting test was conducted where the scuttle to RICER 1 was open during the entire test. From Figures 70 and 71, in comparing natural venting and natural smoke settling, the temperature recovery of natural venting was not as quick as the natural smoke settling. The percent transmittance decreased before it improved, and the recovery time was longer as compared to the other tests (Fig. 73). Also, after the fire was out, temperatures remained 20-30 degrees higher for approximately 12 minutes than the other desmoking fan tests (Figs. 70 and 72).

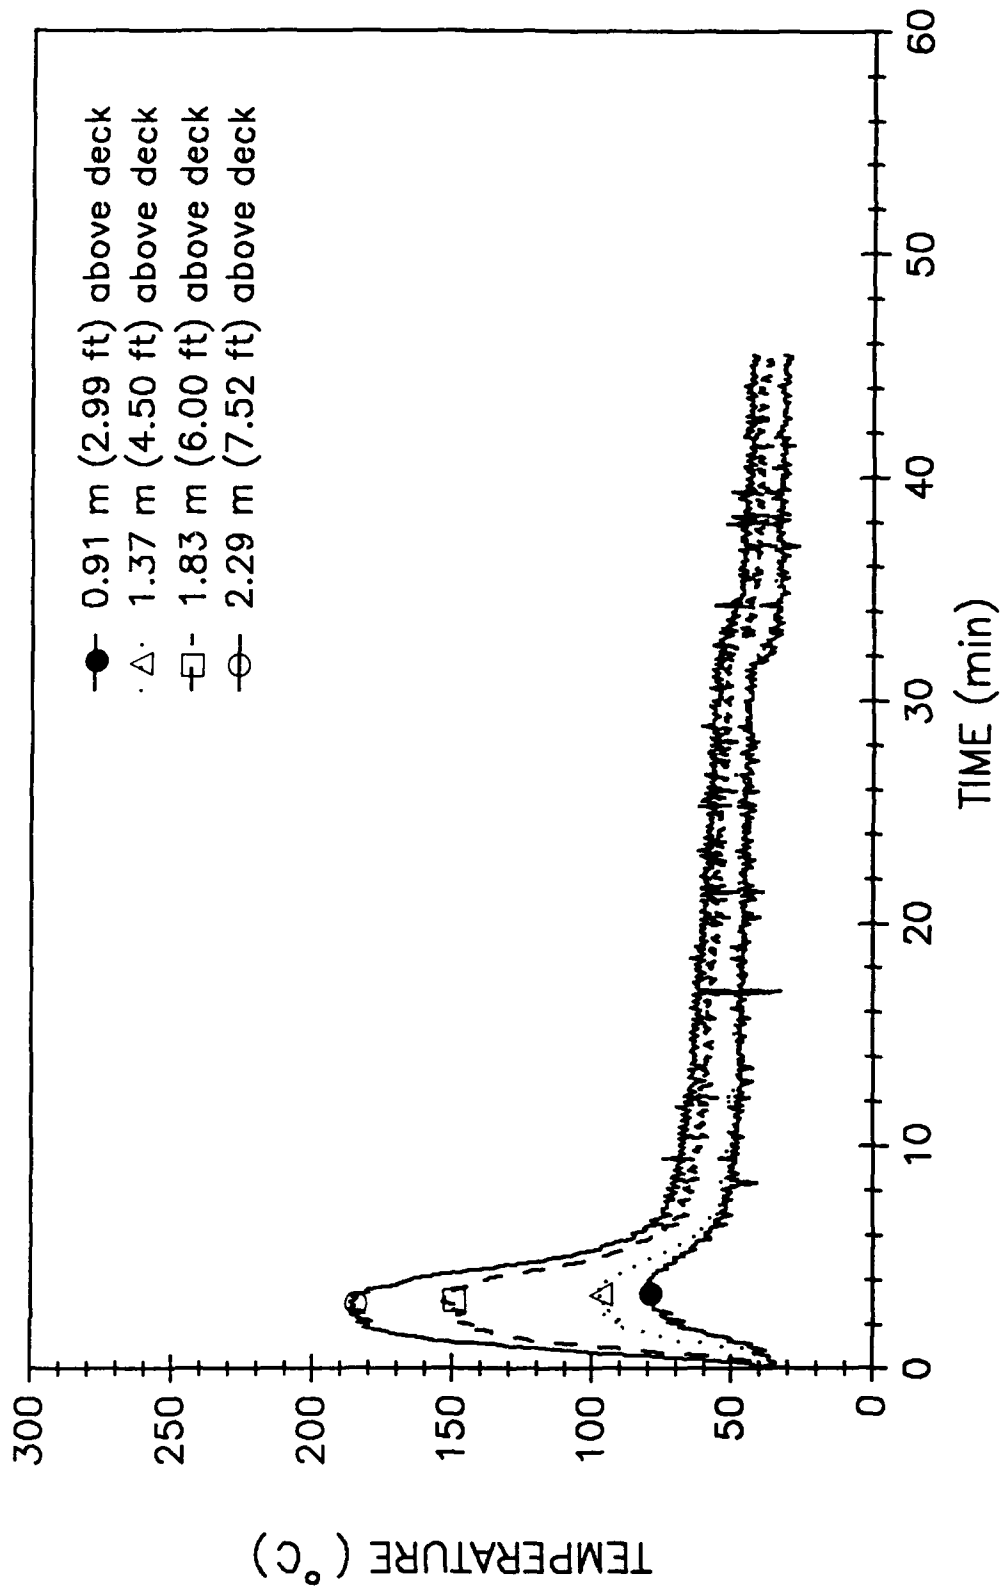
Fig. 71 - Temperature in BERTHING 1 (3-79-2) during FAN\_40 using natural smoke settling

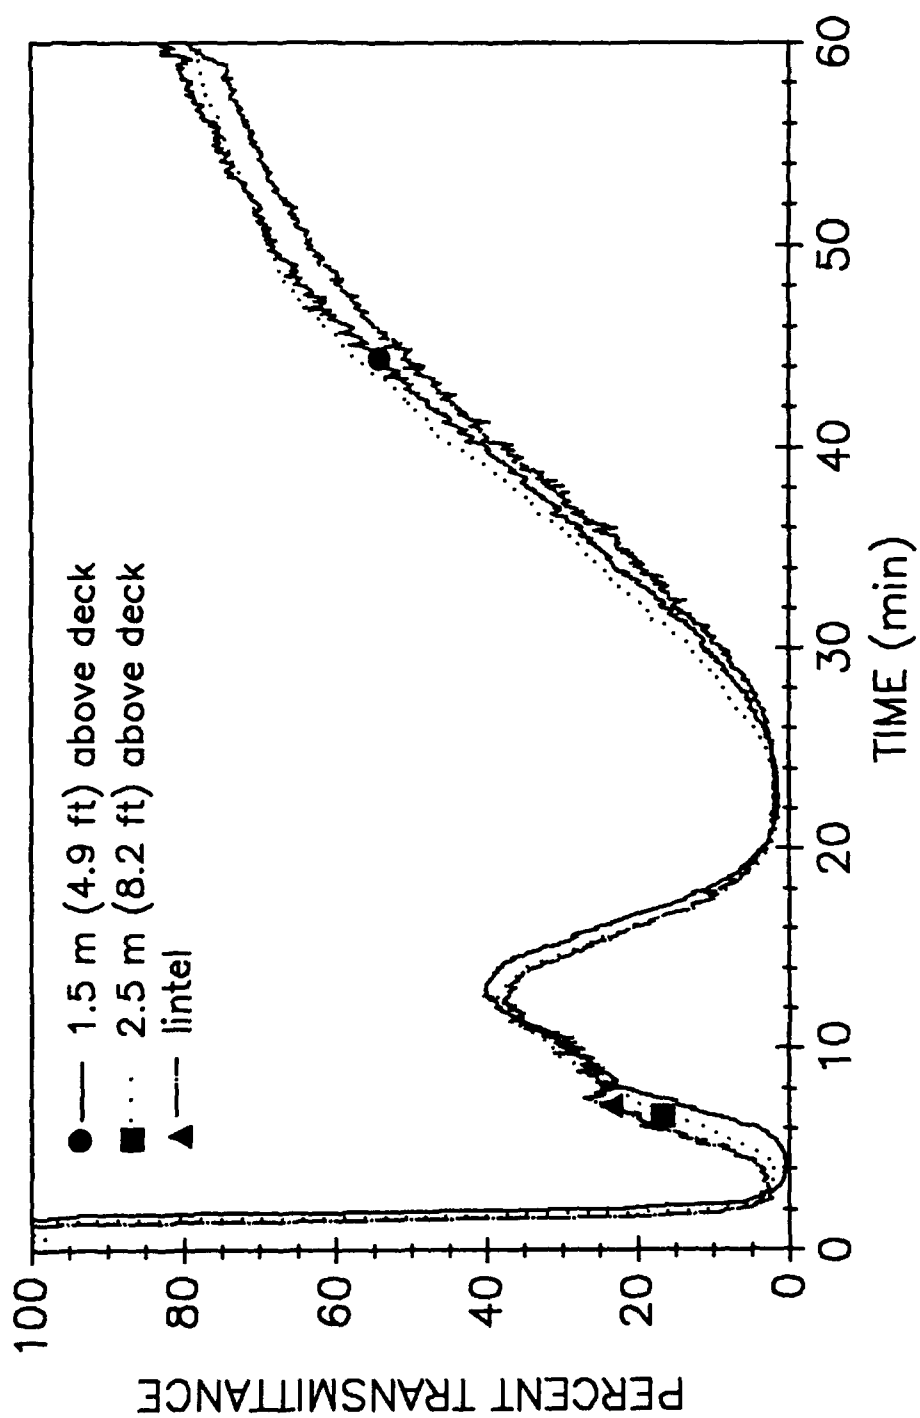
Fig. 73 - Percent transmittance in BERTHING 1 during FAN\_39 using natural venting

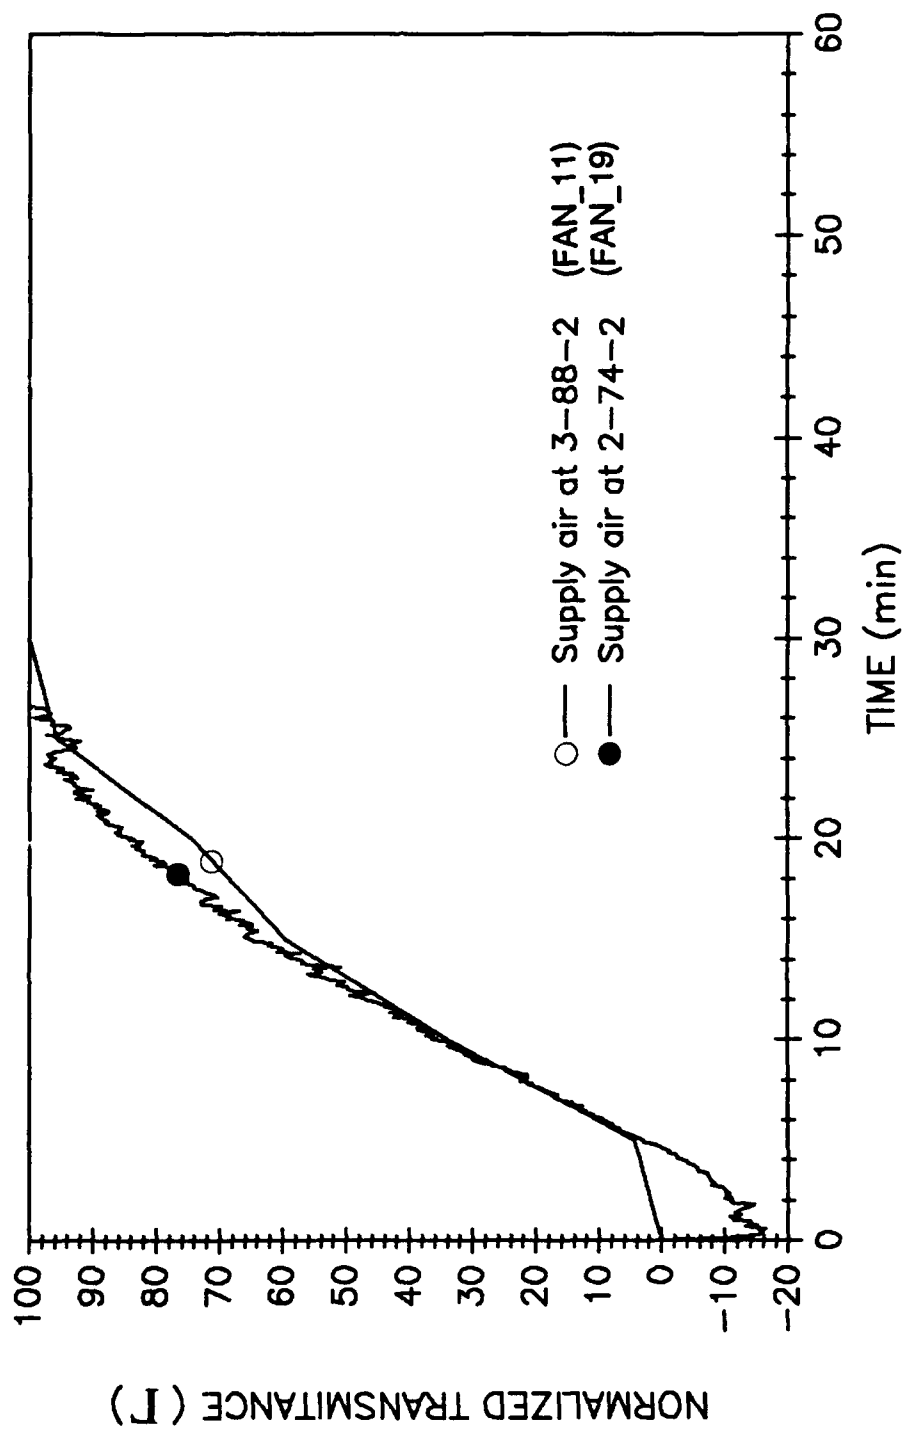
Fig. 74 - Recovery of normalized transmittance in RICER 1 at 2.30  
m level after fan is activated for Red Devil  
25.4 cm (10in) duct

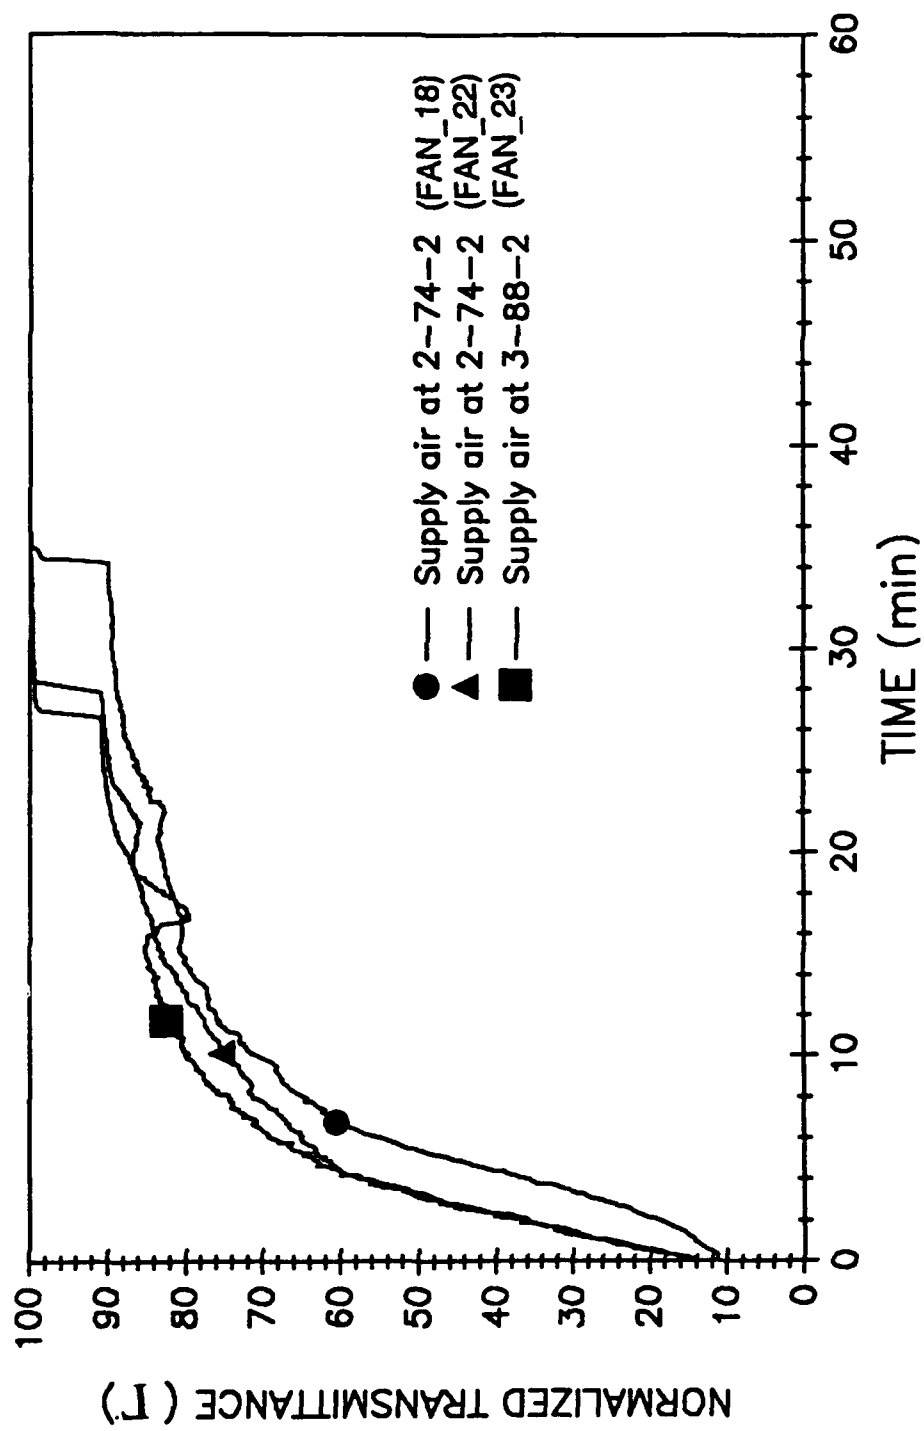
Fig. 76 - Recovery of transmittance in BERTHING 1 at 2.30 m level after fan is activated for RAMFAN 965 kPa (145 psi)

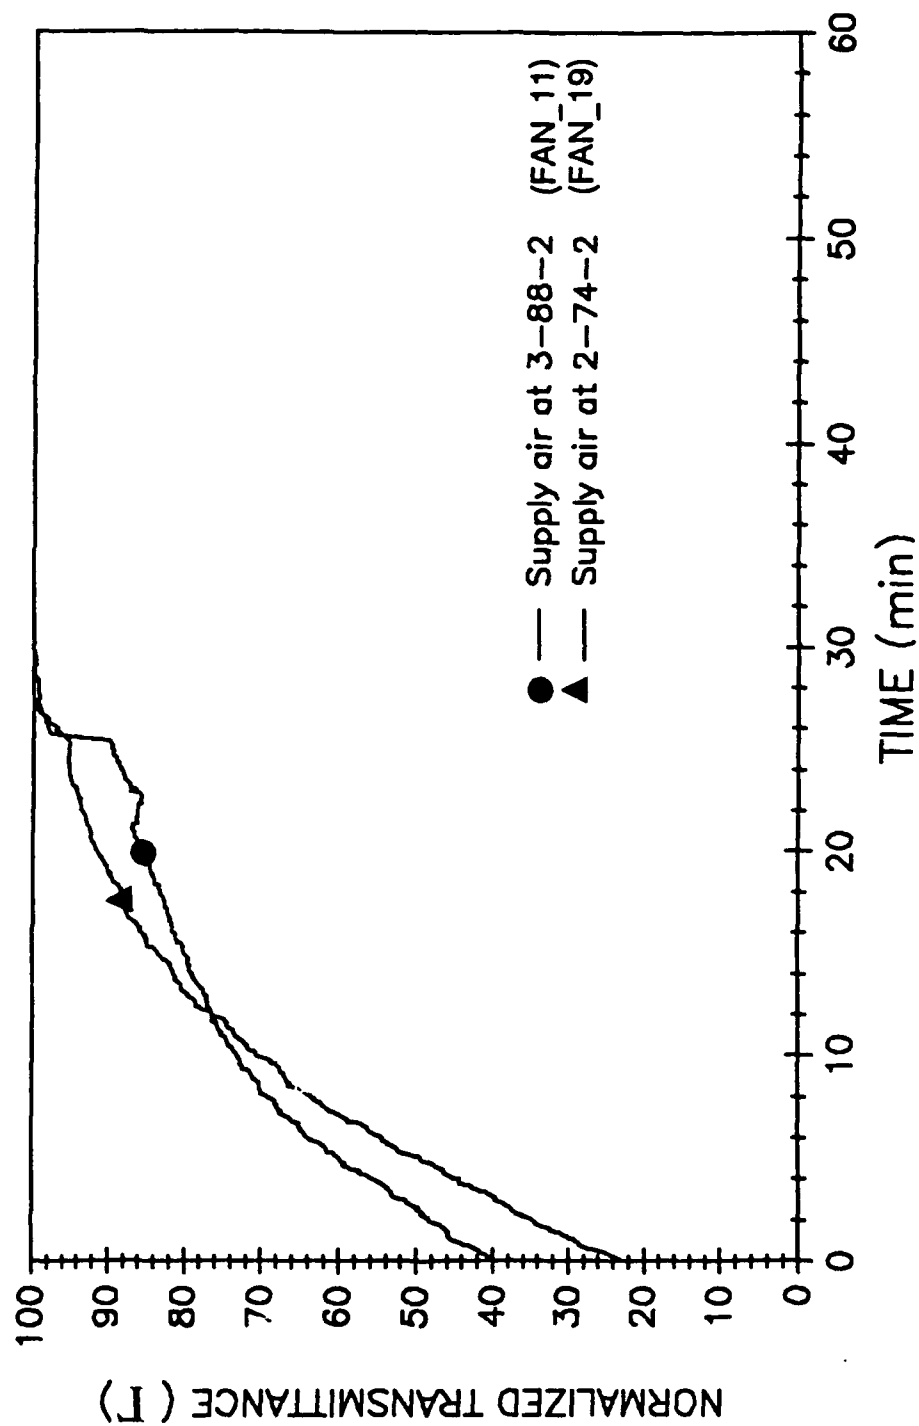
Fig. 77 - Recovery of normalized transmittance in BERTHING 1 at 2.30 m level after fan is activated for Red Devil 25.4 cm (10 in) duct

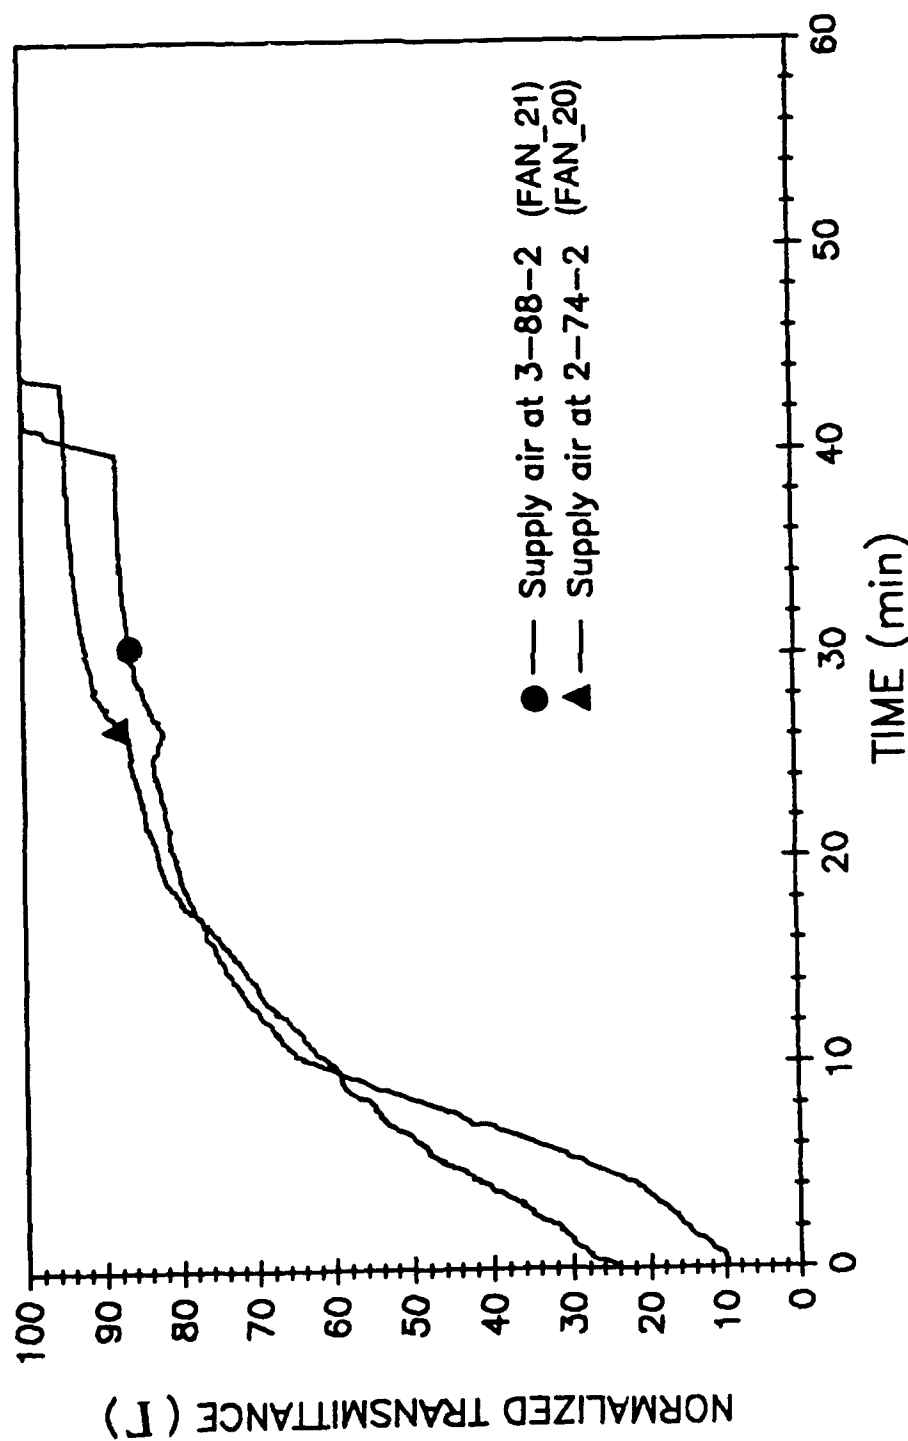
Fig. 78 - Recovery of transmittance in BERTHING 1 at 2.30 m level  
after fan is activated for RAMFAN 345 kPa (50 psi)

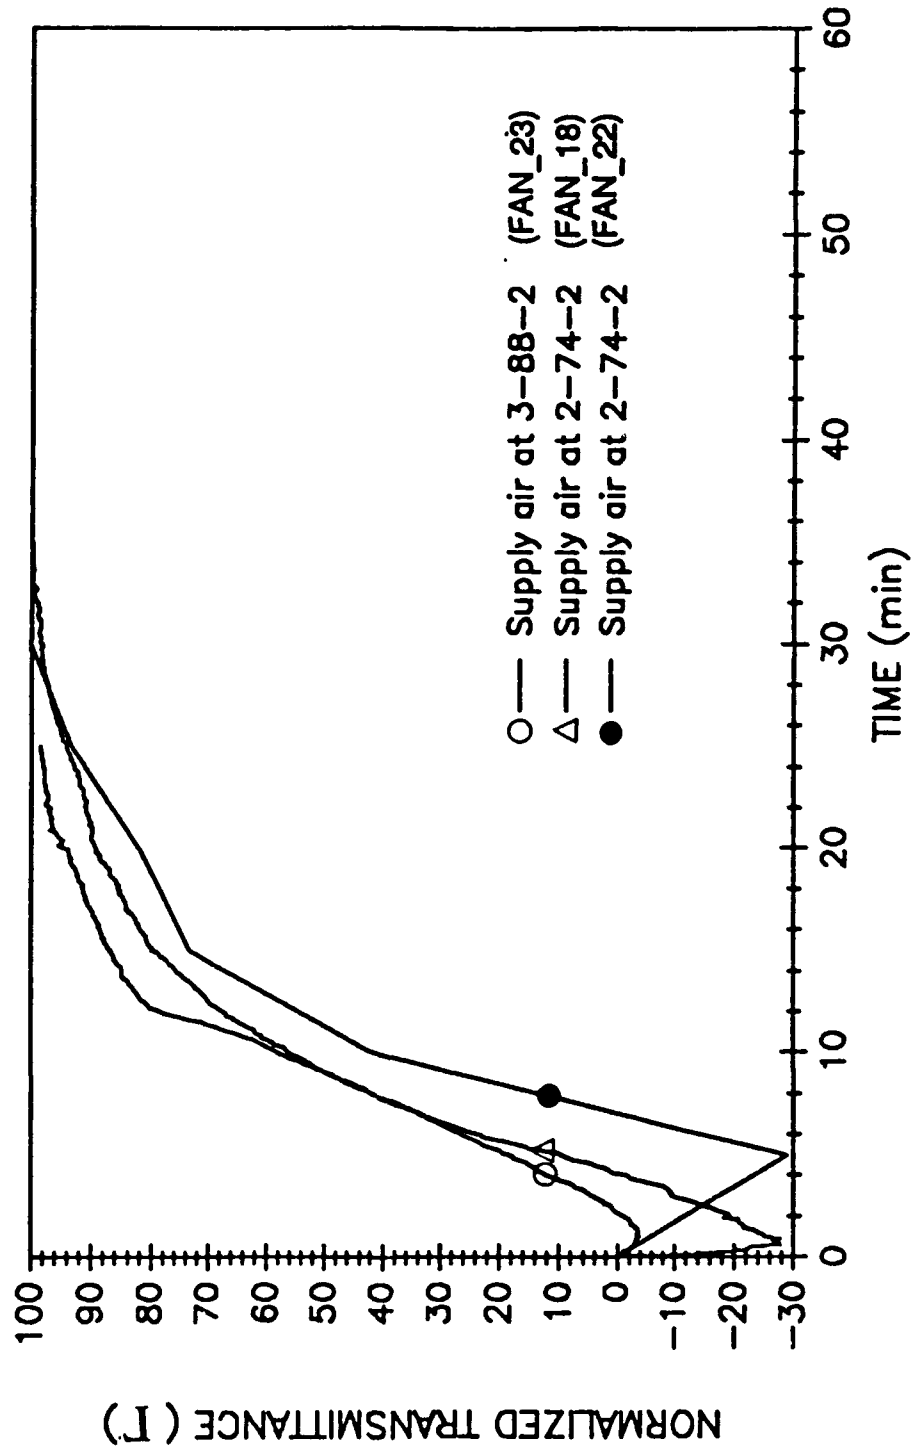
Fig. 79 - Recovery of transmittance in RICER 1 at 2.30 m level  
after fan is activated for RAMFAN 965 kPa (140 psi)

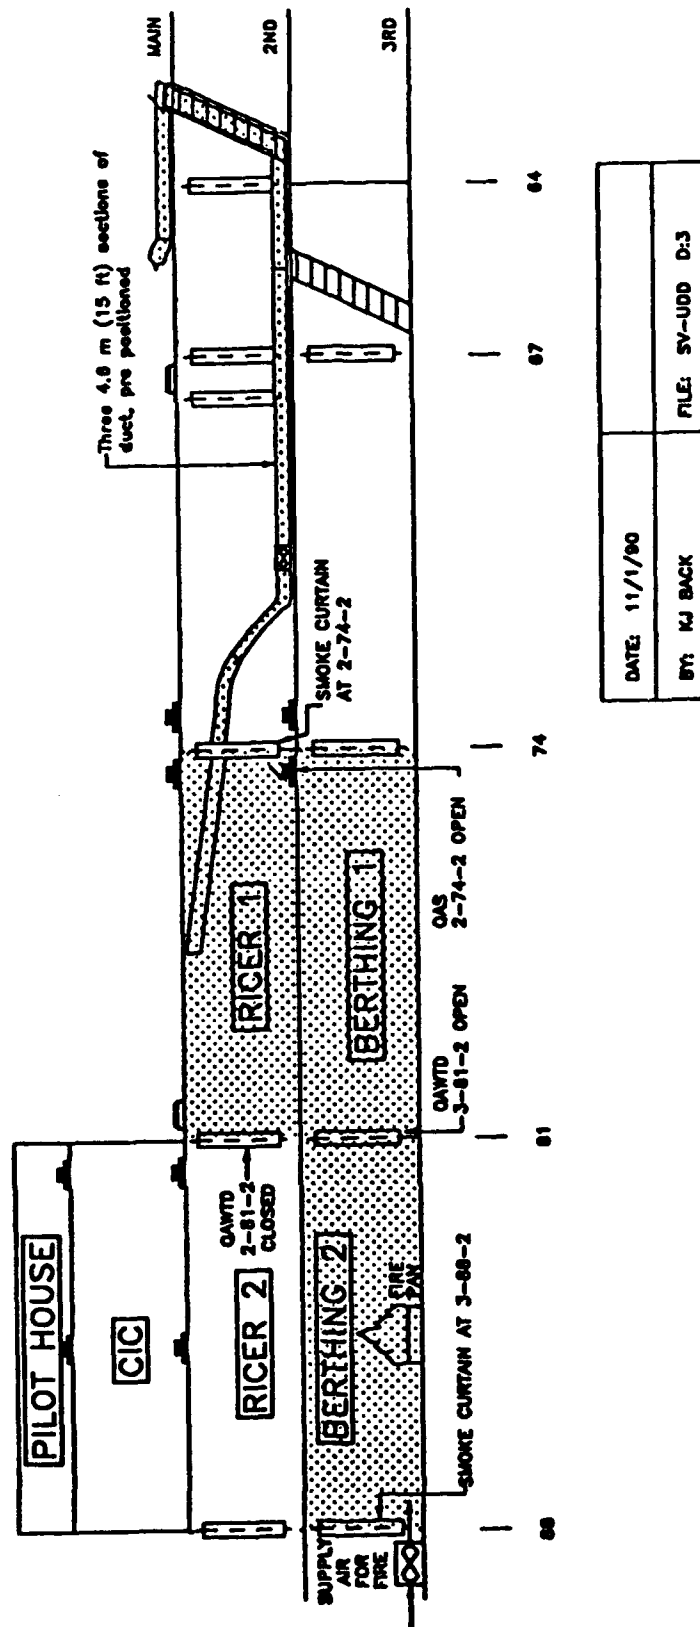
Fig. 80 - Section view, unmanned dynamic desmoking

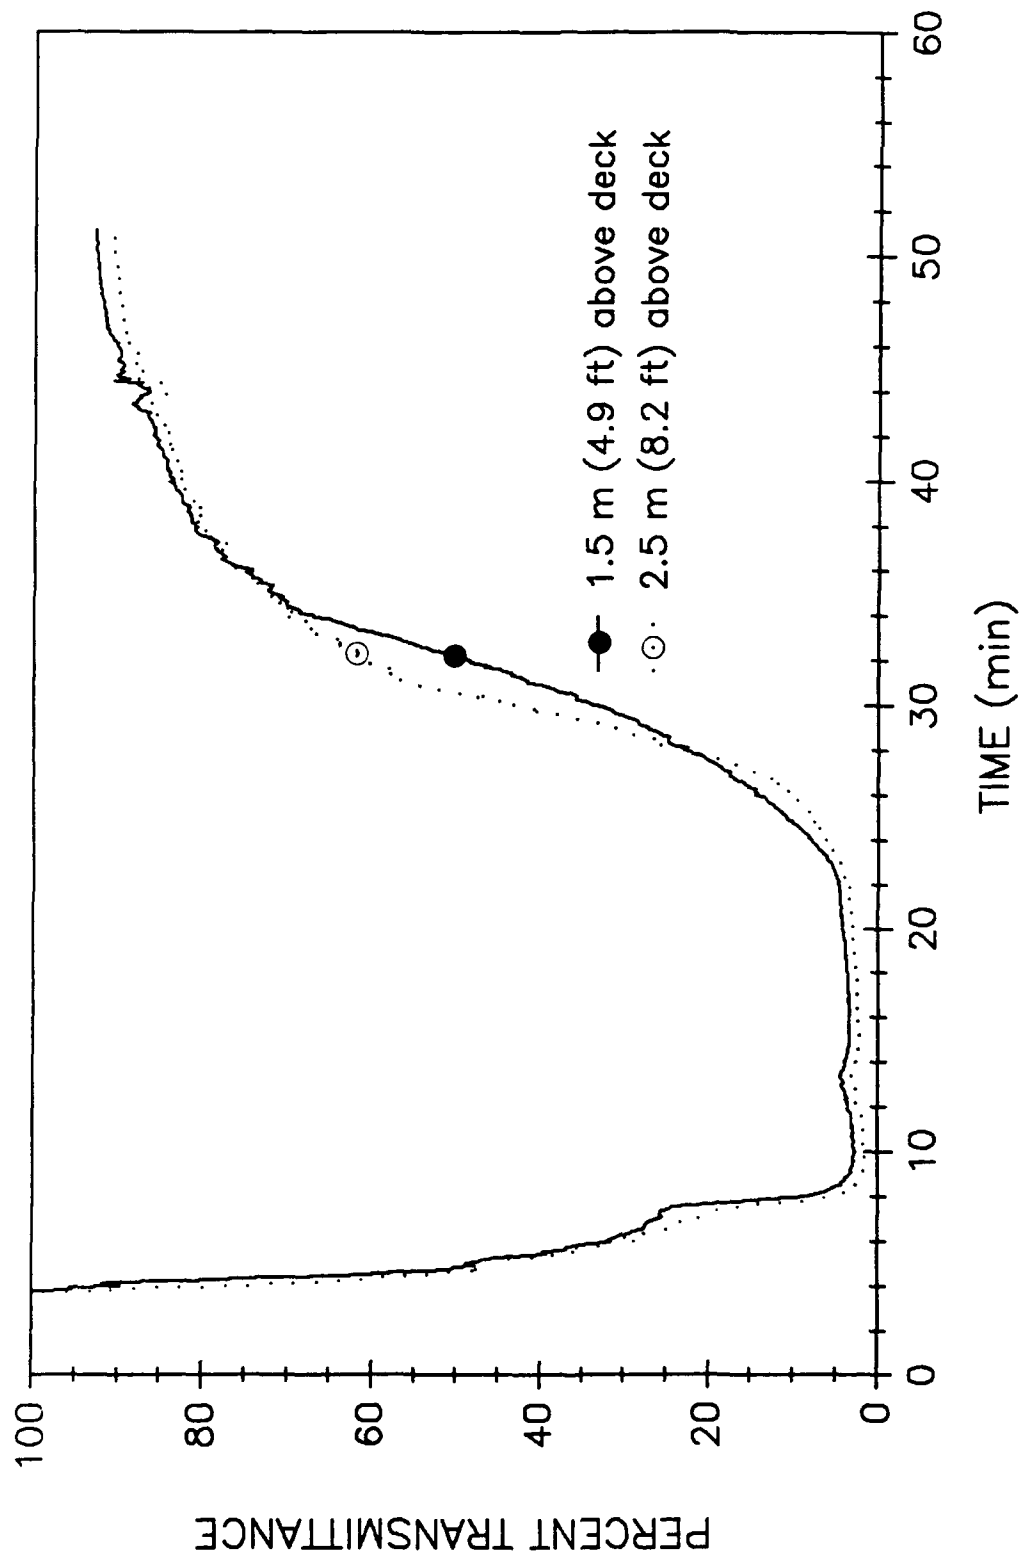
Fig. 85 - Percent transmittance in RICER 1 during FAN\_25  
using Red Devil 25.4 cm (10 in) duct

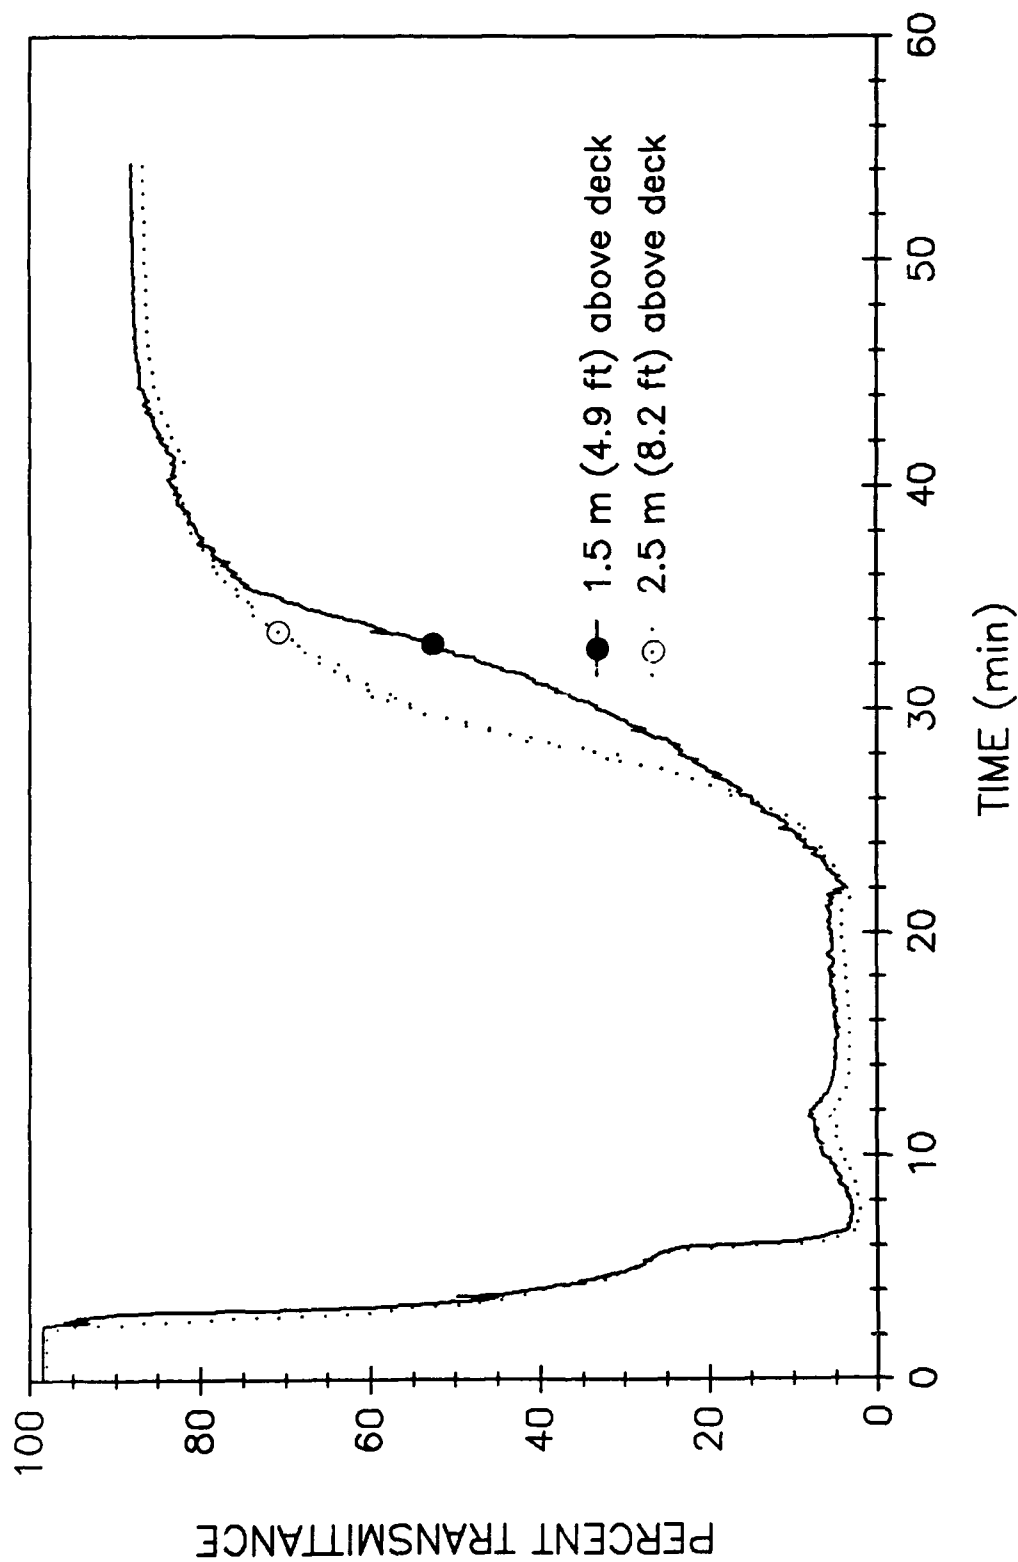
Fig. 86 - Percent transmittance in RICER 1 during FAN\_28  
using RAMFAN 965 kPa (145 psi) supplied by P-250
